INSTRUMENTATION APPENDIX TO
PERIODIC INSPECTION REPORT NO. 5
UNION VILLAGE DAM, VERMONT

Haley & Aldrich, Inc.
Cambridge, Massachusetts

Department of the Army
New England Division

File No. 11163-006
July 1995

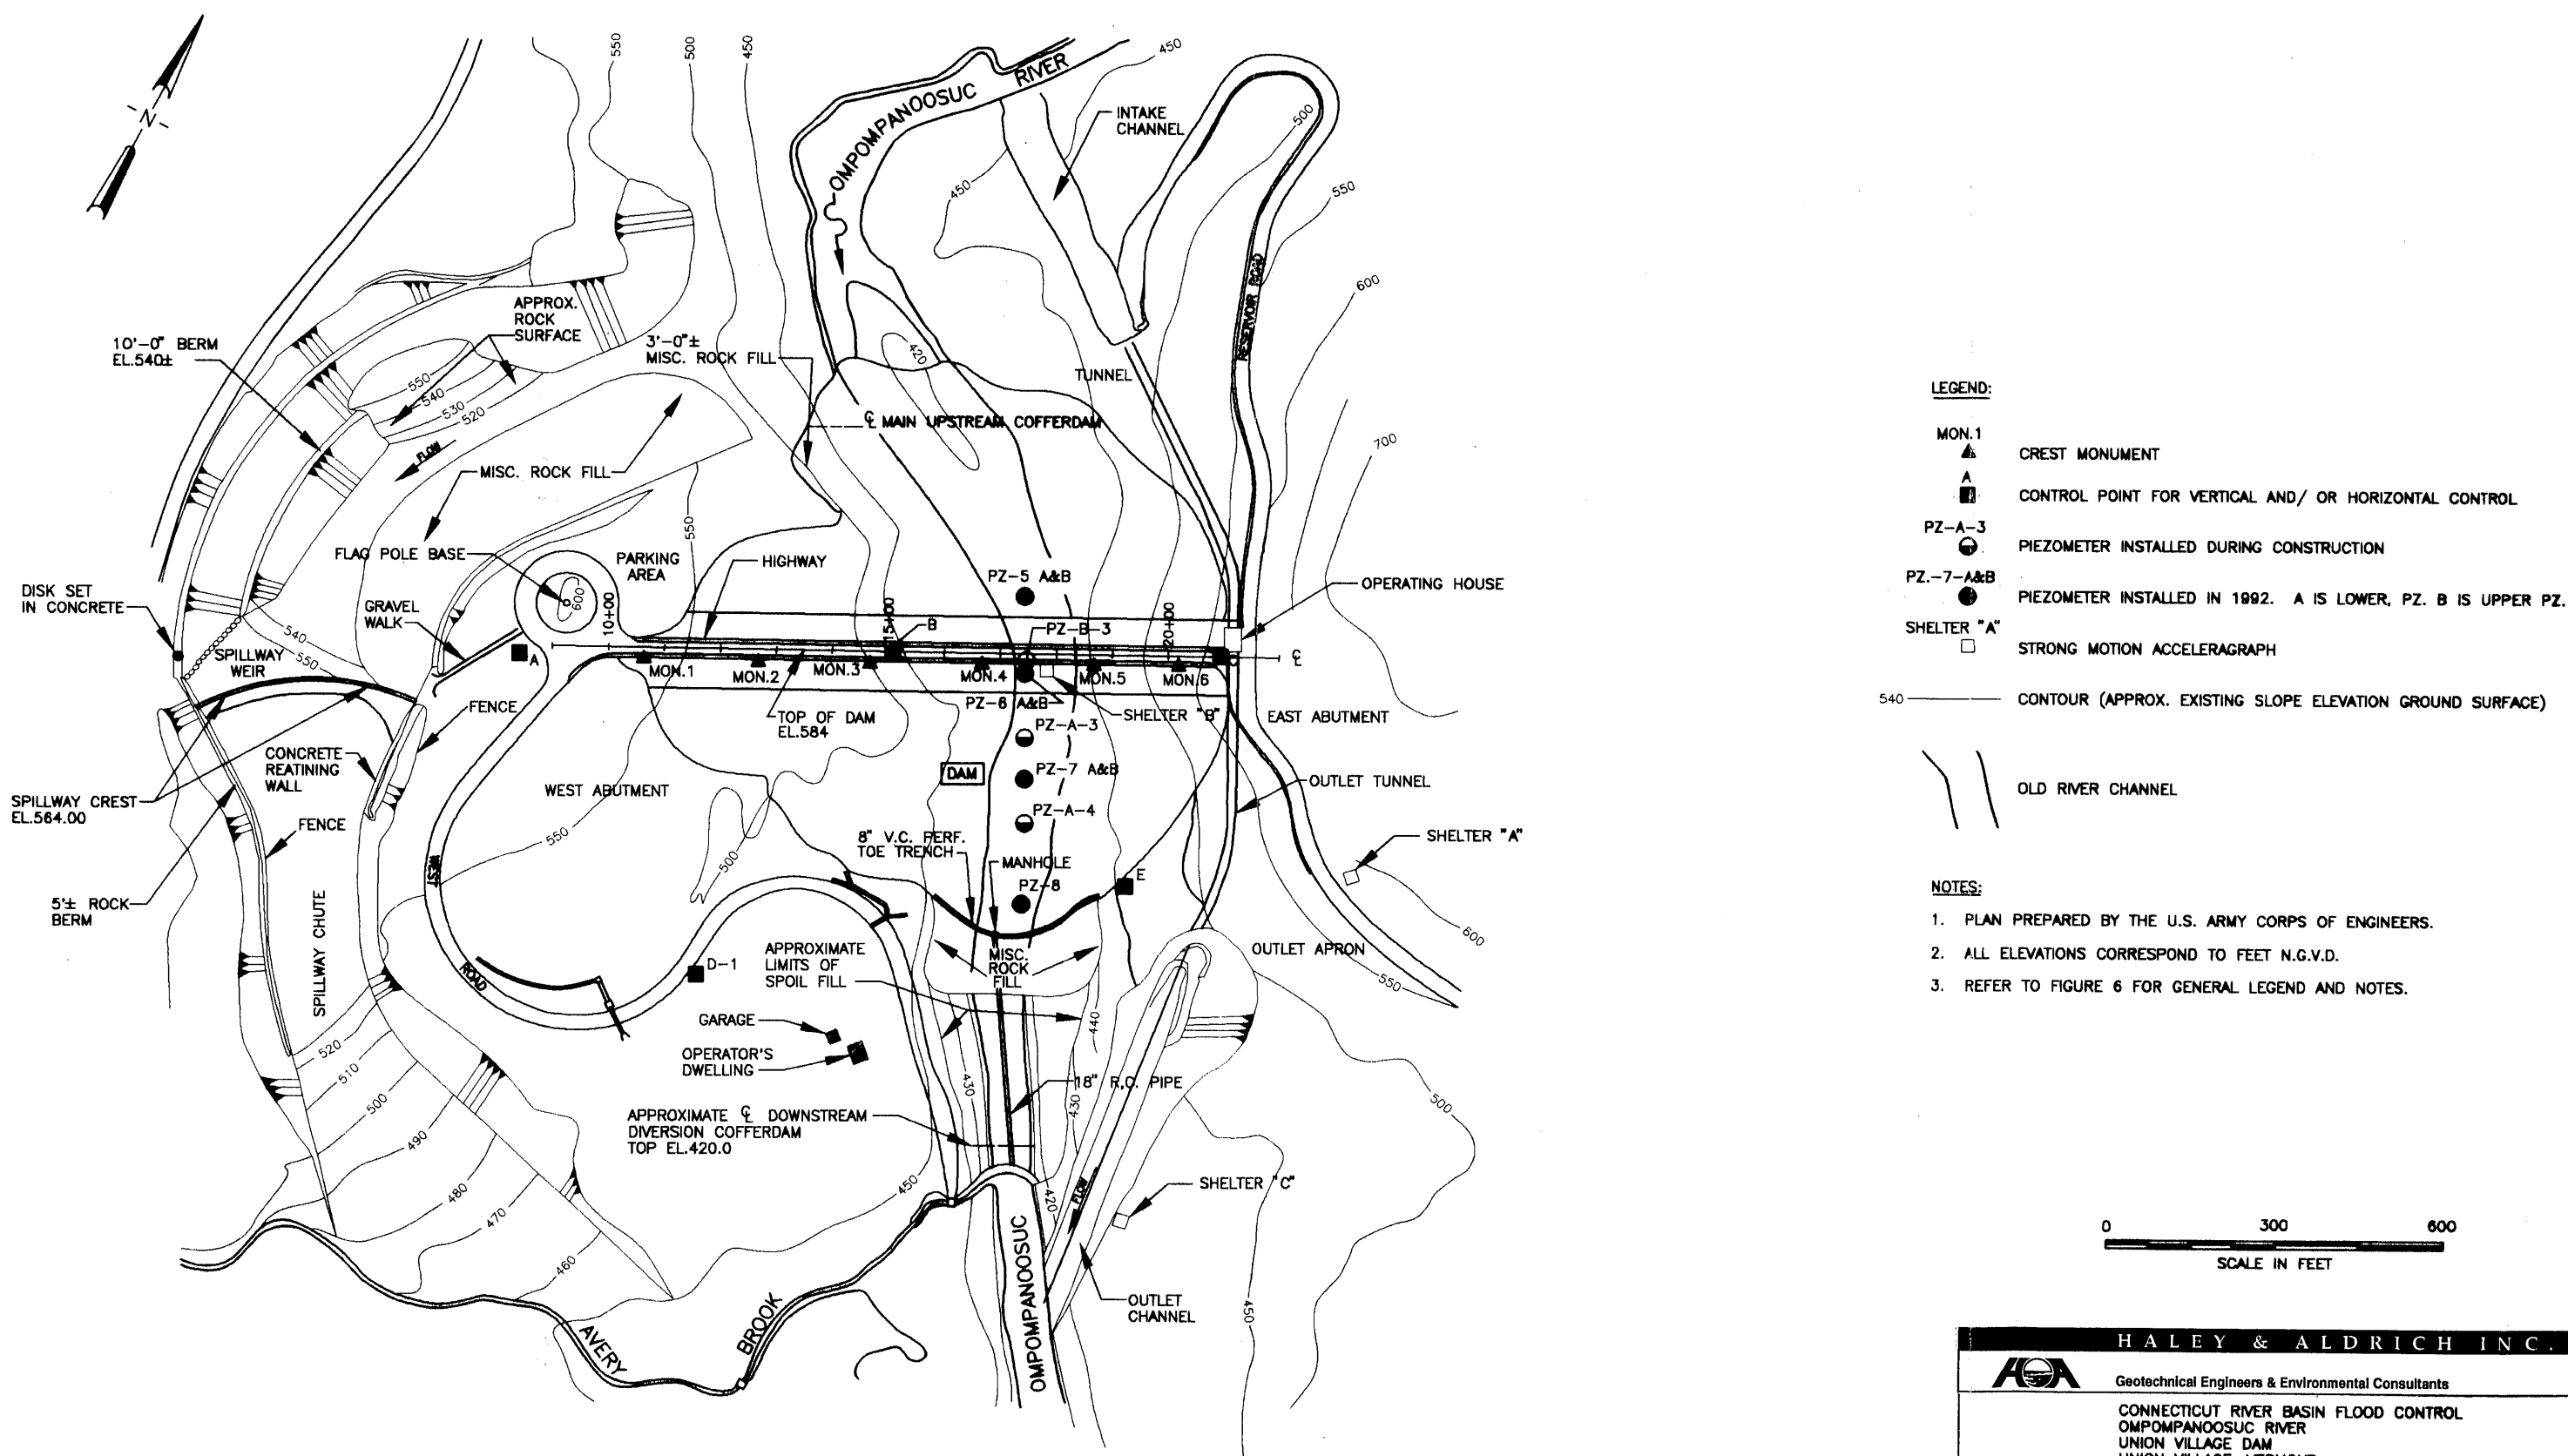
FIGURE 5

a. General. Instrumentation to monitor embankment performance at Union Village Dam consists of three strong motion accelerographs, six crest survey monuments, three piezometer/settlement gages and seven piezometers (three double and one single). The location plan of the instrumentation is shown on Figure 5.

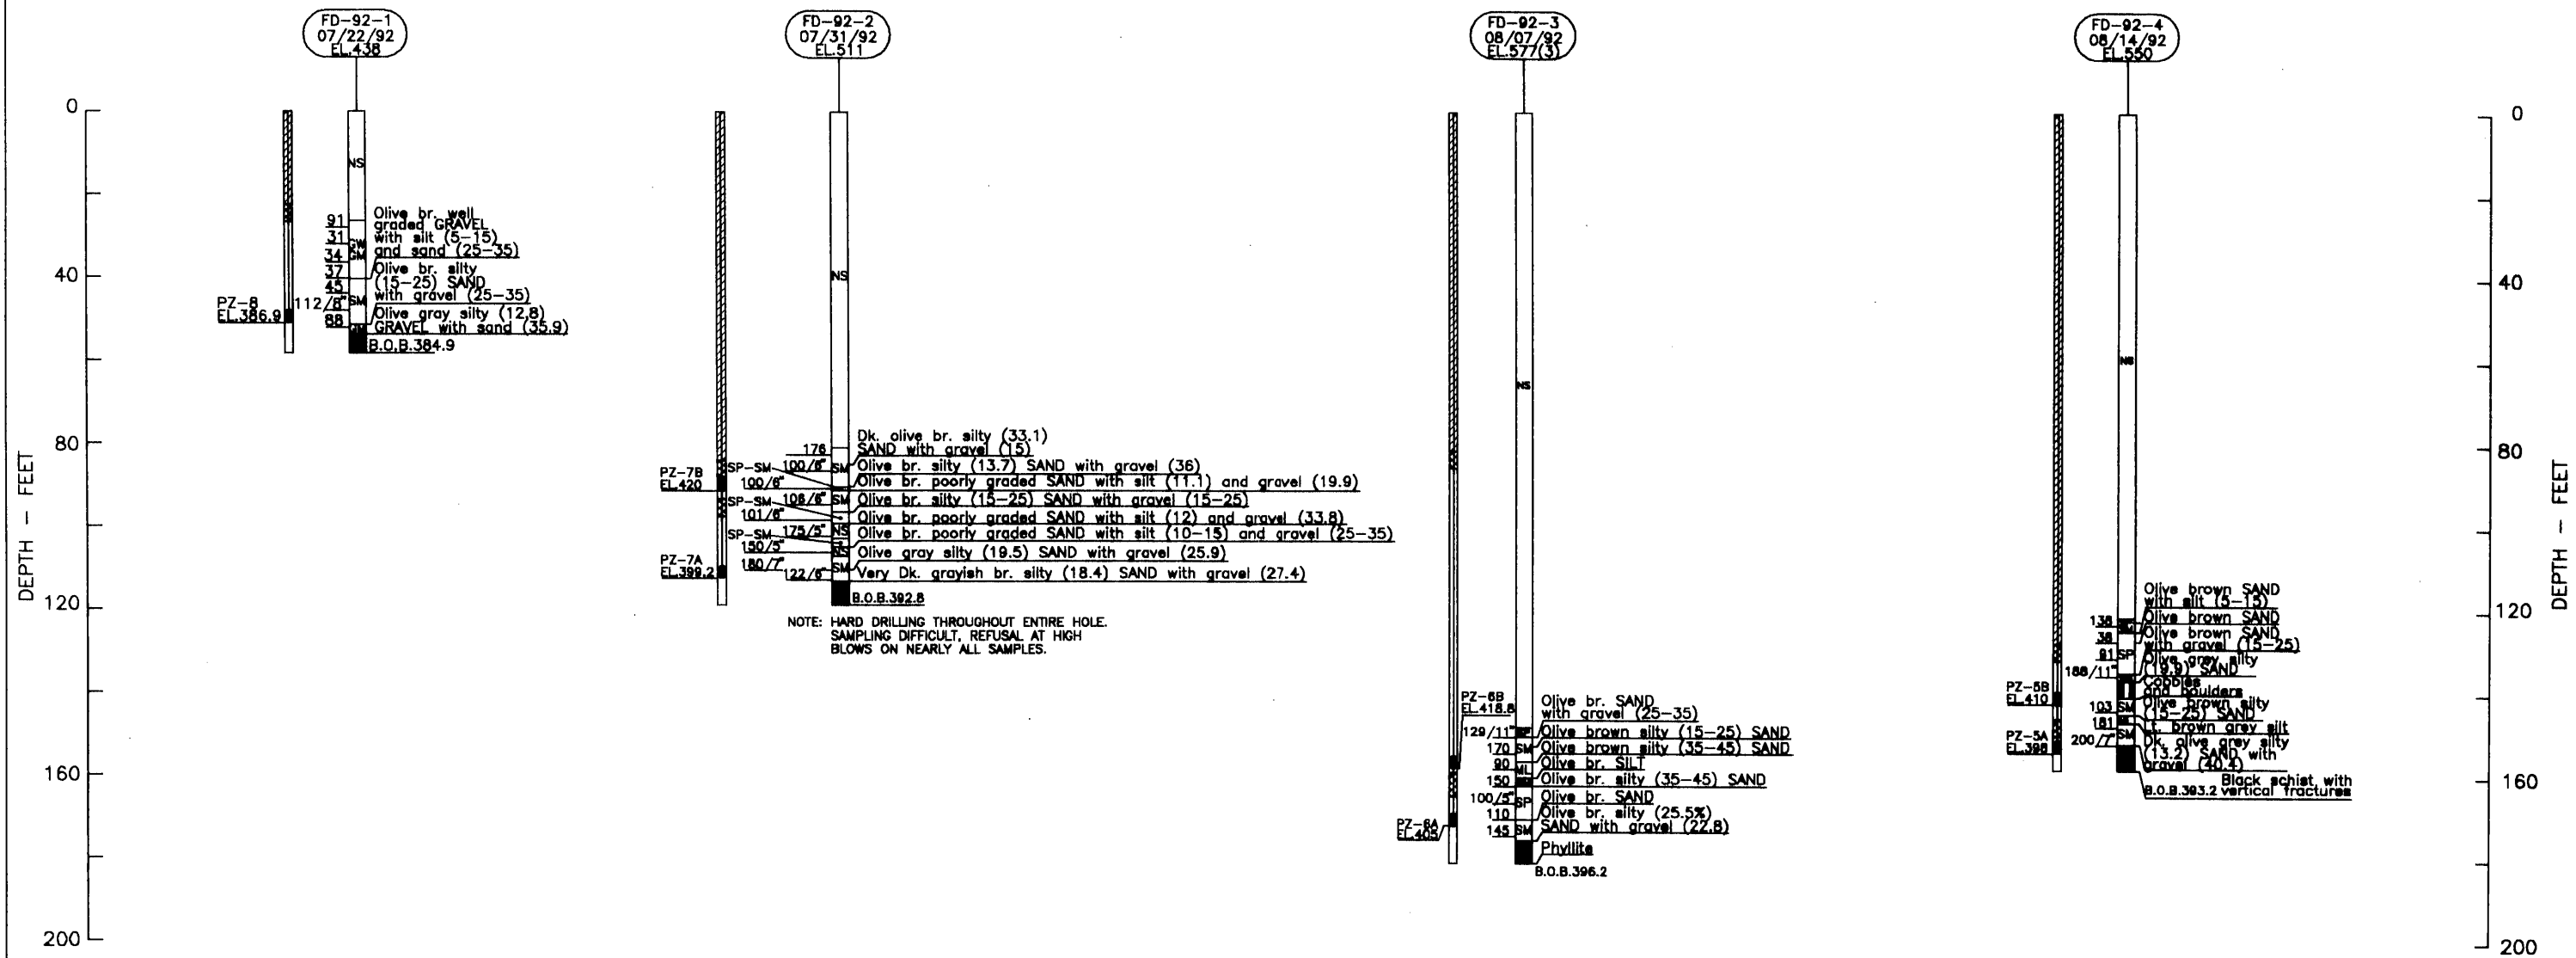
FIGURE 7

c. Piezometers. Fifteen open type piezometers were installed during construction, located on the crest, upstream and downstream slopes, and right abutment. Since then all but three (A-3, A-4, and B-3) have been abandoned. In 1992, seven Casagrande open-type piezometers (three double and one single) were installed at the locations shown on Figure 5. The test boring and piezometer logs for the piezometers installed in 1992 are presented on Figure 7.

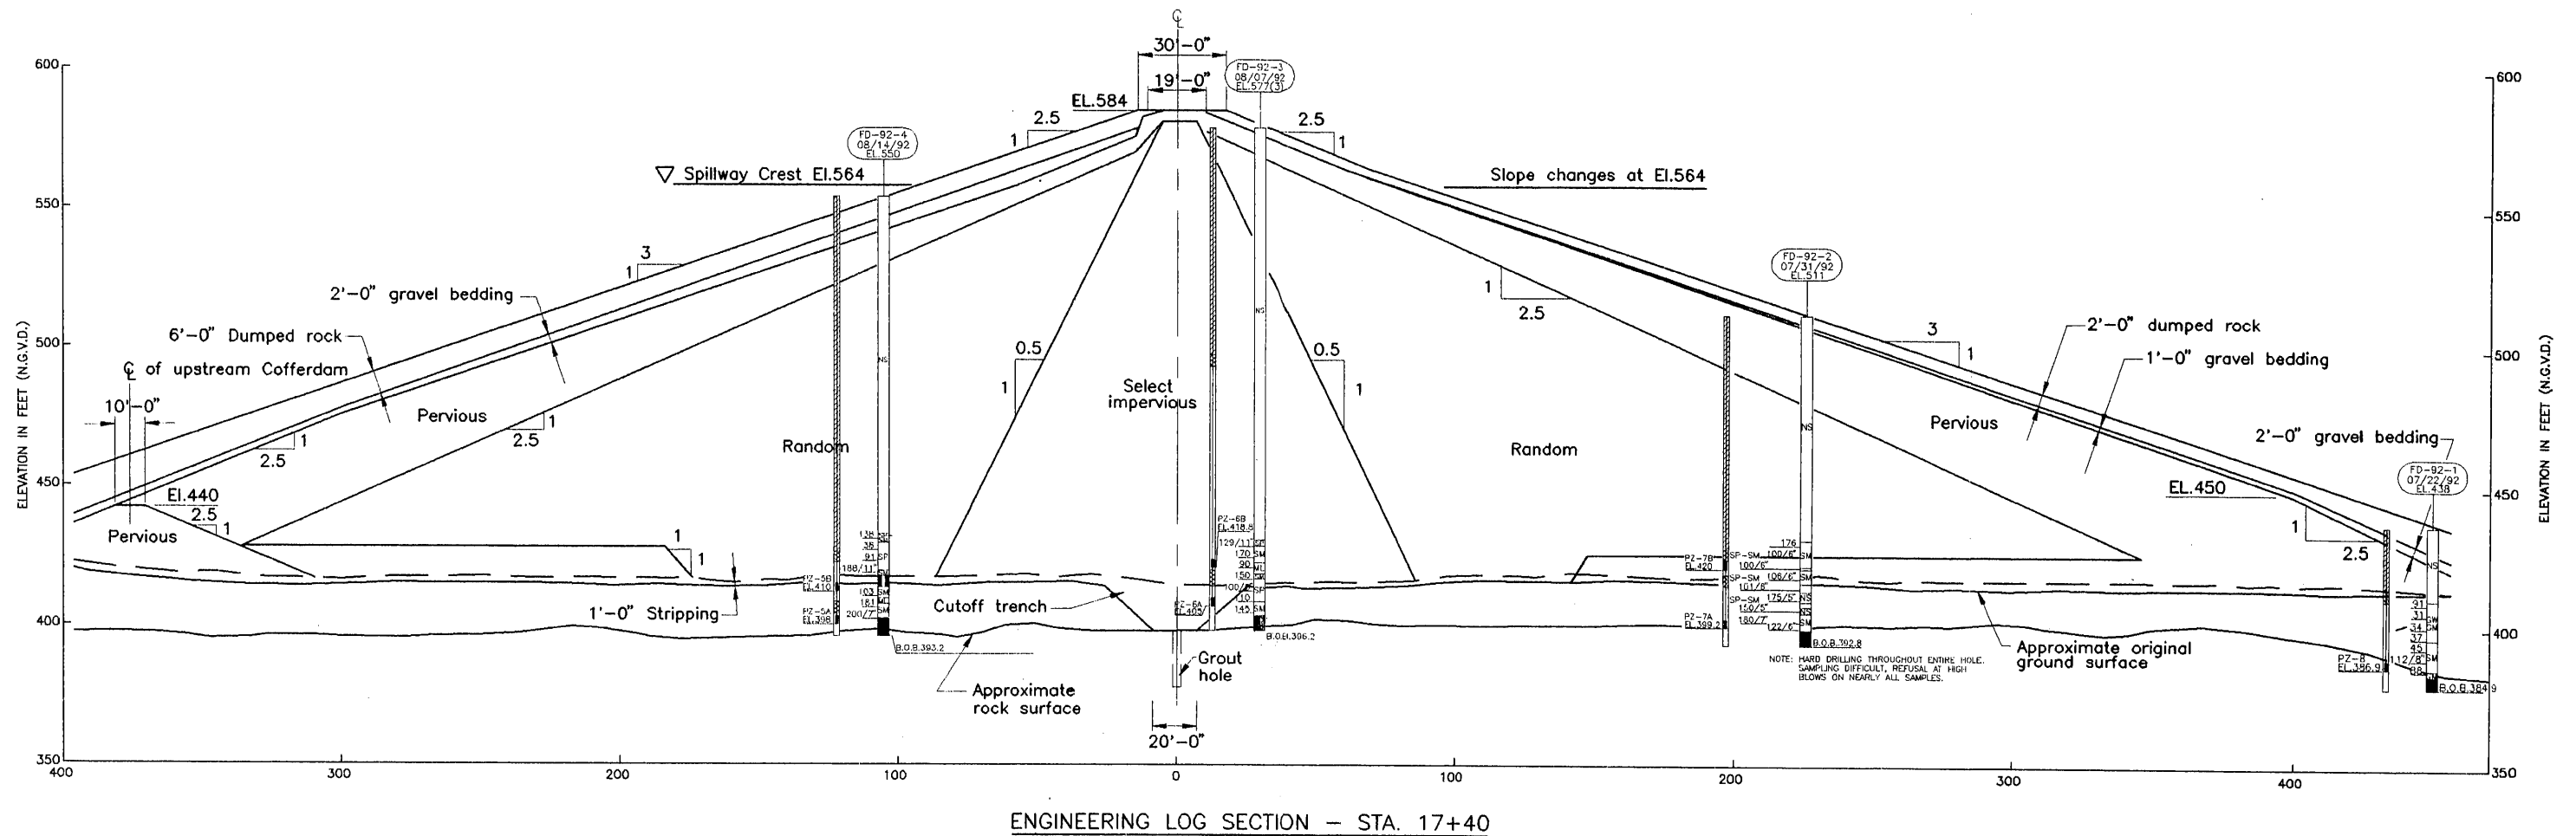
FIGURE 8

(5) PZ-5B. PZ-5B was installed in 1992 and is approximately located at Sta. 17+40, offset 105 ft upstream from the dam centerline. The top of the riser pipe is at El. 552. The piezometer tip is located just below the foundation/embankment interface at El. 410 in olive brown silty (15-25) SAND (SM). The piezometer consists of a wick of filter sand that extends 14 ft upward from El. 406 to a bentonite seal as shown in Figure 8.

(7) PZ-6B. PZ-6B was installed in 1992 and is approximately located at Sta. 17+40, offset 30 ft downstream from the dam centerline. The top of the riser pipe is at El. 579. The piezometer tip is located in the select impervious embankment zone at El. 418.8 in olive brown silt (ML). The piezometer consists of a wick of filter sand that extends 72.8 ft upward from El. 417.3 to a bentonite seal as shown in Figure 8.

(8) PZ-7A. PZ-7A was installed in 1992 and is approximately located at Sta. 17+40, offset 225 ft downstream from the dam centerline. The top of the riser pipe is at El. 513. The piezometer tip is located just above the bedrock/foundation interface at El. 399.2 in very dark grayish brown silty (18.4) SAND with gravel (27.4) (SM). The piezometer consists of a wick of filter sand that extends 21.2 ft upward from El. 392.8 to a bentonite seal as shown in Figure 8.

(10) PZ-8. PZ-8 was installed in 1992 and is approximately located at Sta. 17+40, offset 450 ft downstream from the dam centerline. The top of the riser pipe is at El. 440. The piezometer tip is located just above bedrock in the stratified foundation at El. 386.9 in olive brown silty (15-25) SAND with gravel (25-35) (SM). The piezometer consists of a wick of filter sand that extends 31 ft upward from El. 380 to a bentonite seal as shown in Figure 8.

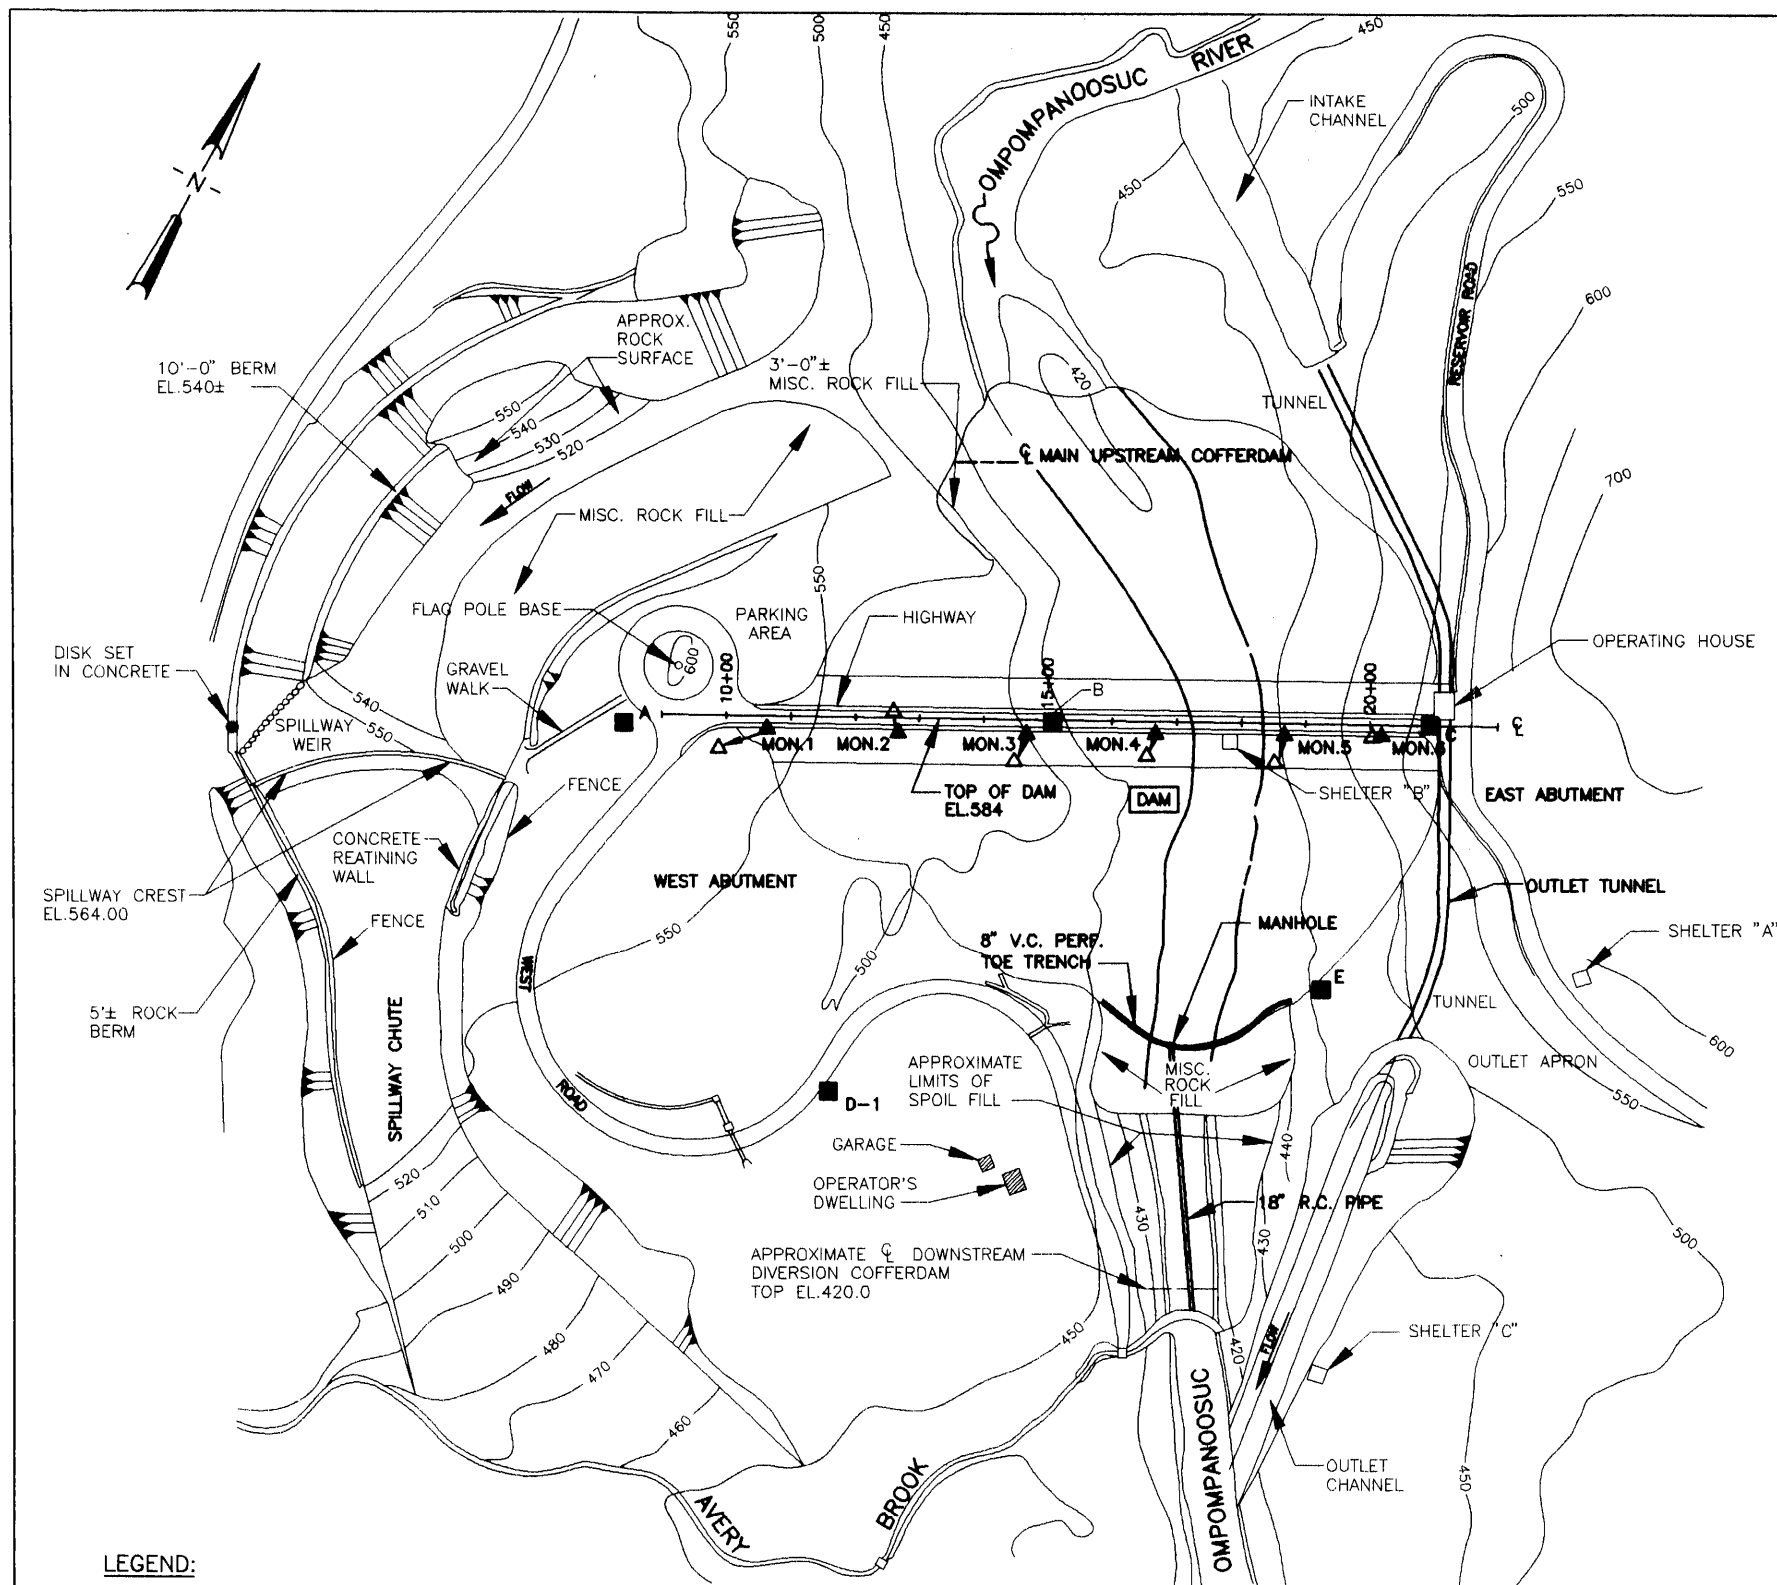
FIGURE 10

The results from the 1985 and 1994 survey indicate horizontal movements less than 0.05 ft (0.6 in.), with a typical pattern of downstream movement as shown in Figure 10. However, this range of movement is within the range of third order accuracy.

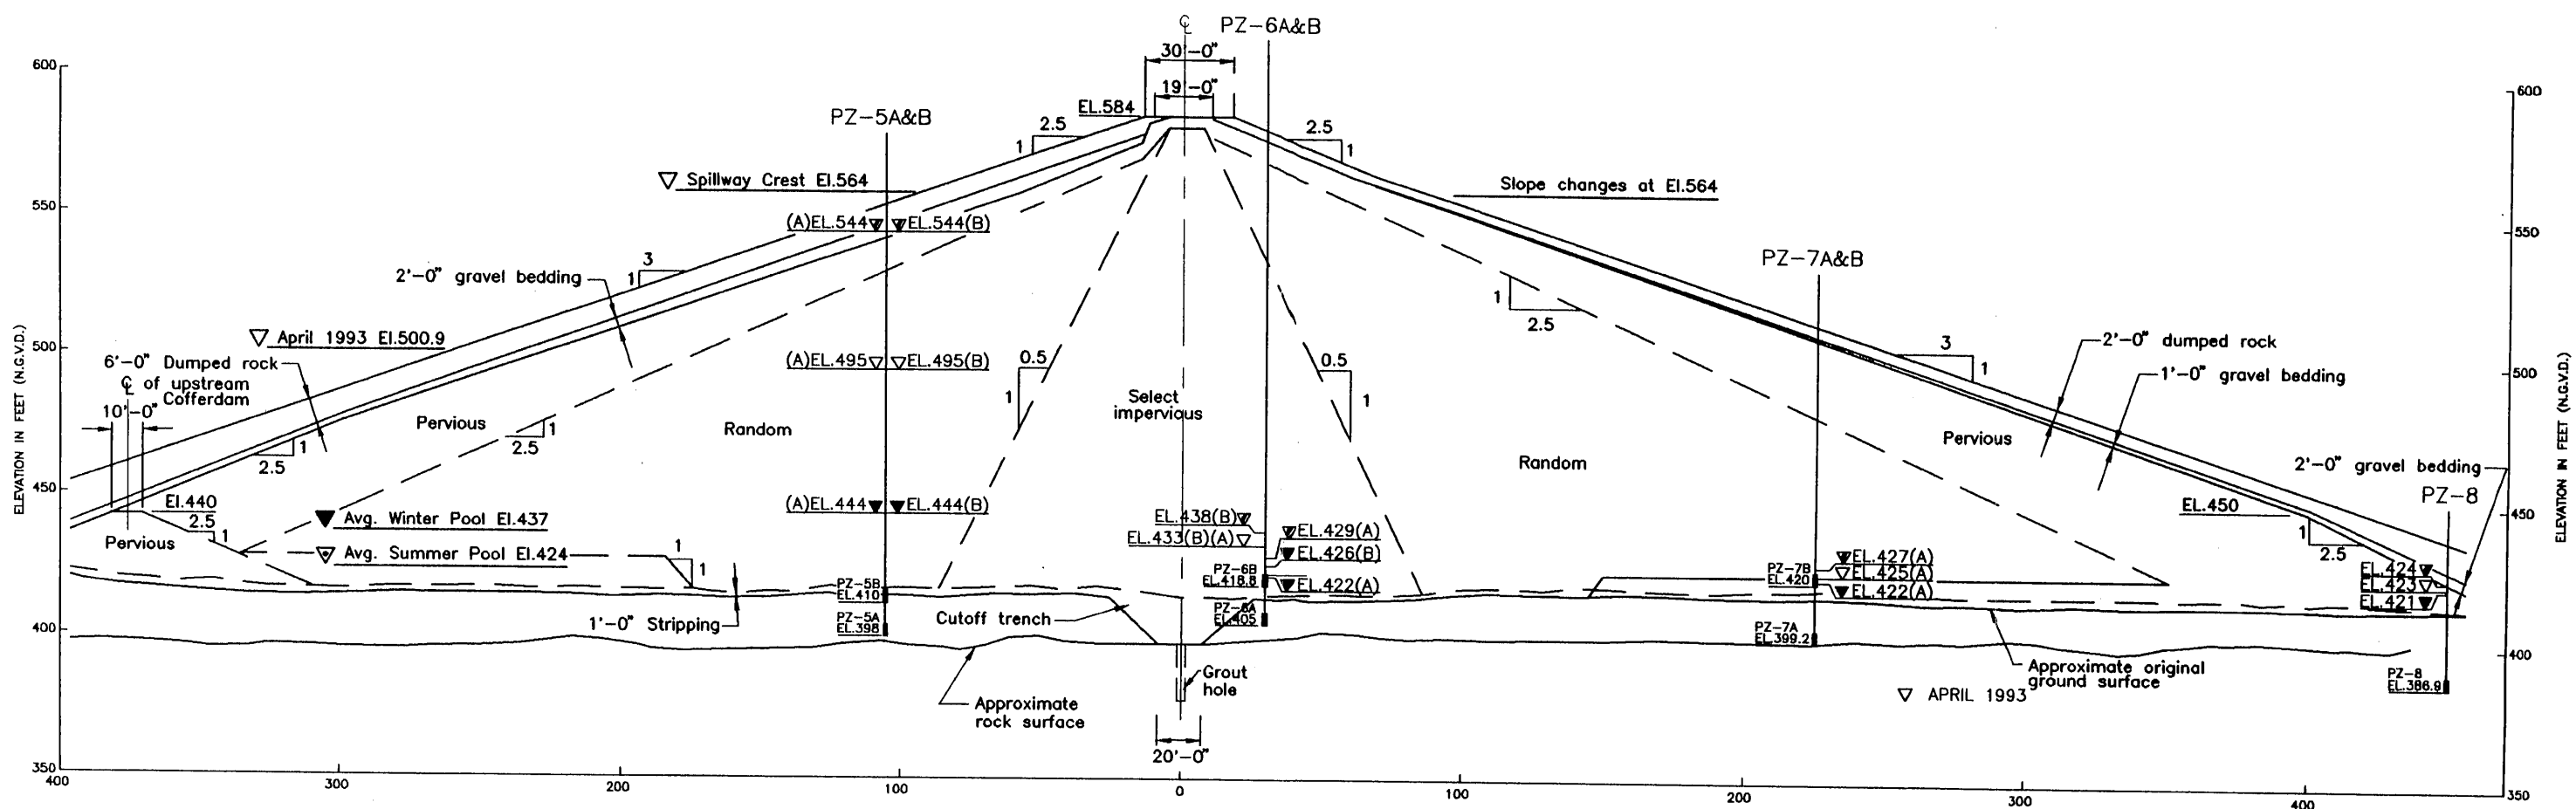
ENGINEERING LOG SECTION - STA. 17+40

(9) PZ-7B. PZ-7B was installed in 1992 and is located at Sta. 17+40, offset 225 ft downstream from the dam centerline. The top of the riser pipe is at El. 513. The piezometer tip is located at El. 420 in the downstream random fill zone in olive brown poorly graded SAND with silt (11.1) and gravel (27.4) (SP-SM). The piezometer consists of a wick of filter sand that extends 4.9 ft upward from El. 418.1 to a bentonite seal as shown in Figure 8. PZ-7B provided no readings during the period October 1, 1992 through October 31, 1994. The piezometer tip was apparently installed above the normal tailwater level which controls the water level in the lower random fill zone.

1. CROSS SECTIONS PREPARED BY THE U.S. ARMY CORPS OF ENGINEERS AND PUBLISHED IN THE REPORT ENTITLED "PERIODIC INSPECTION REPORT NO. 1, UNIONVILLE DAM, CONNECTICUT RIVER BASIN, OMPOMPANOOSUC RIVER, VERMONT."
2. ALL ELEVATIONS CORRESPOND TO FEET N.G.V.D.
3. REFER TO FIGURE 6 FOR GENERAL LEGEND AND NOTES.
4. PZ-7B READ DRY FROM OCTOBER 1, 1992 THROUGH OCTOBER 31, 1994.
